Electric Utility Accident Report

RE: Contractor Shock and Burn LG&E Beargrass Creek Switching Station Louisville, KY

INVESTIGATION REPORT

Accident investigation report
Beargrass -Northside 138kV OPGW Installation for Insight Communications
LG&E Project # 114159

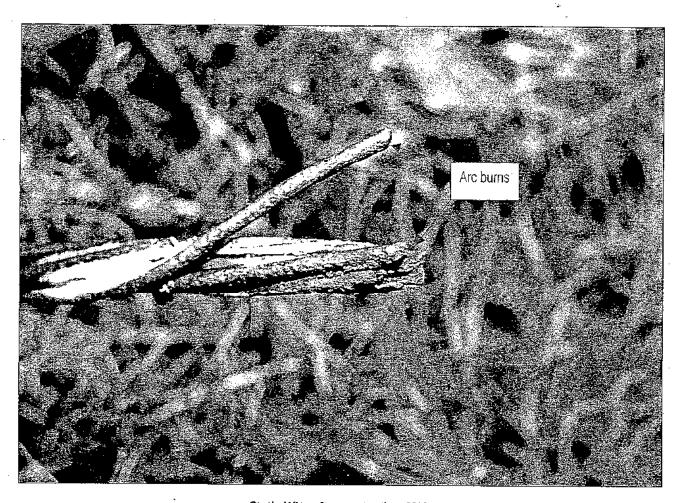
Inspection of the static wire that was being replaced has found that only the end of the wire has been damaged by an electrical arc. This has led to the assumption that the static wire came out of or broke at the connection shoe on the top of the tower. There were no other marks on the old static wire. Based on current information, it is not possible to conclusively rule out that the static wire was lowered into contact with the 69KV line before falling.

Static Wire after contacting 69Kv

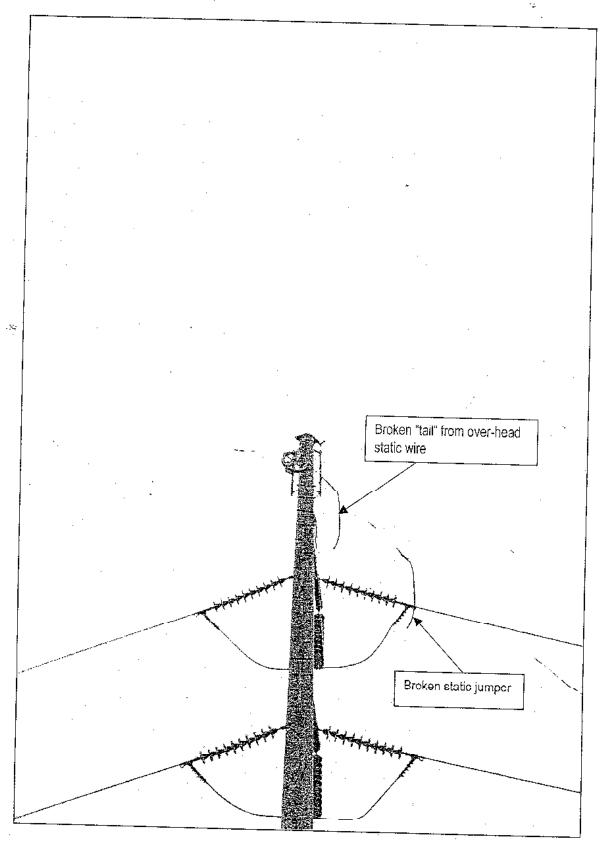
The static wire being replaced was disconnected at the pole and was being let down using a rope hand line and pulley. The hand line was being operated from the ground. The static line being replaced was still connected to the tower (structure 1-F). Mr. Hudson was on the ground and was to release the old static from the rope hand line. When the static wire was on the ground Mr. Hudson approached the static wire and removed a chain jack that was also on the end of the rope. As Mr. Hudson was taking the old static wire off of the rope it appears that the other end that was connected at the top of the tower (structure 1-F), either broke at the connection shoe or came loose at the connection and fell.

Structure # 1-E ~ Close up showing Static "tail" after breaking
